Section 19 Flood and Water Management Act 2010

Yoxford Flood Investigation -

Storm Babet 2023

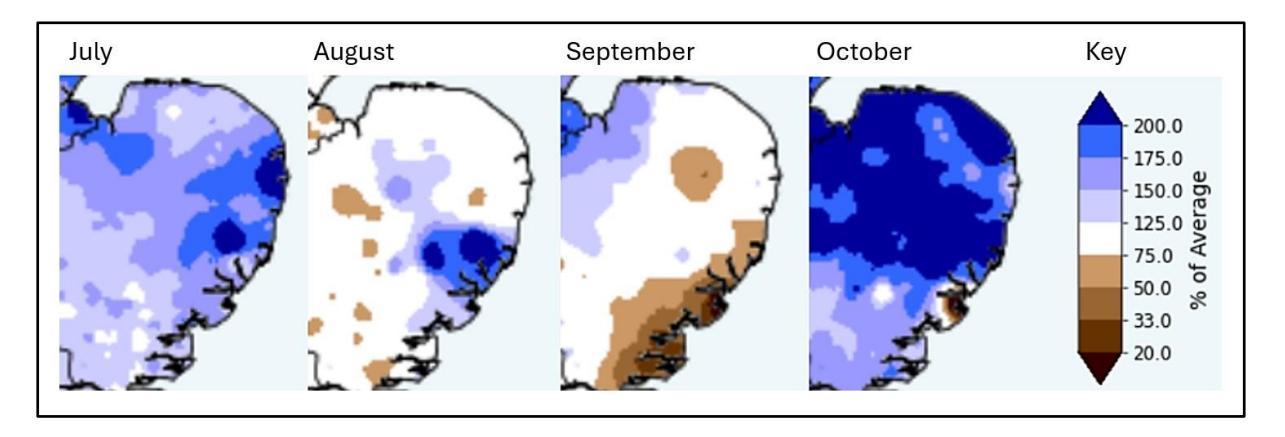
Figure 1. Average rainfall in East Anglia between July and October 2023 as a percentage of the historical average monthly rainfall

The following maps illustrate the extent to which the rainfall in the months preceding Storm Babet exceeded the average monthly rainfall for July to October in recent years in Suffolk.

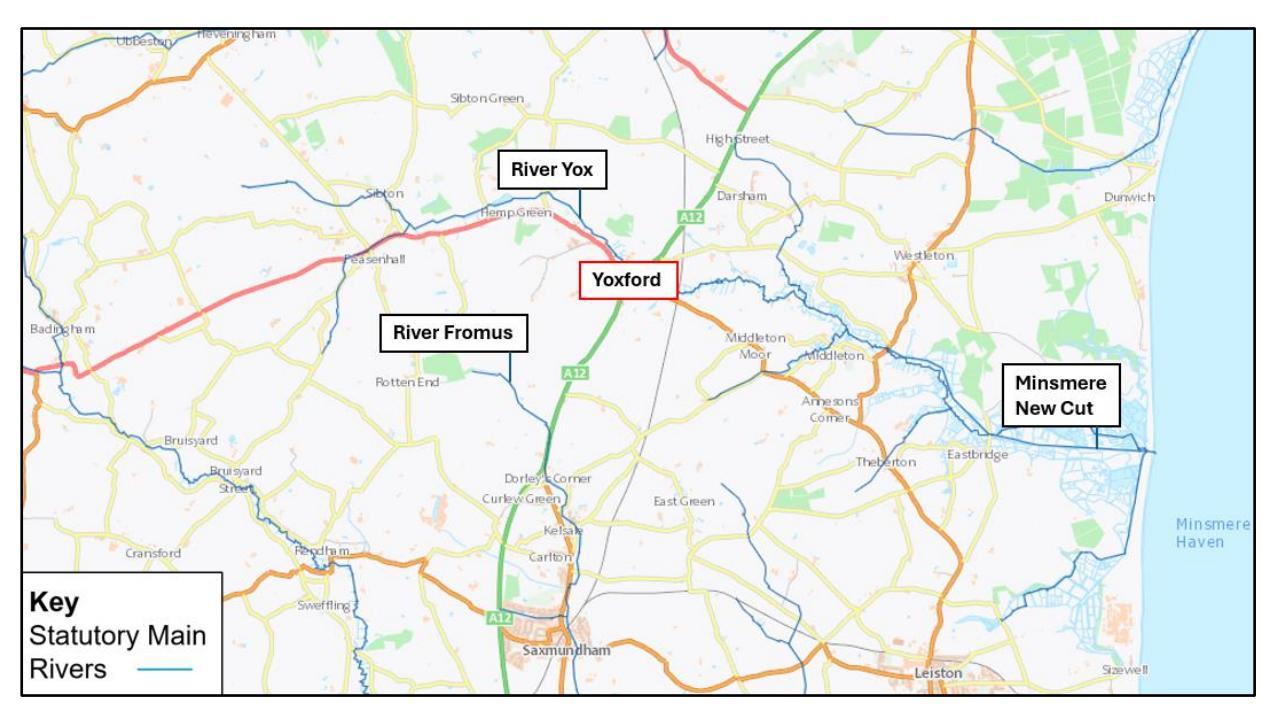
Figure 3. Location of statutory main rivers and significant ordinary watercourses near Yoxford

Figure. 3 shows the most significant watercourses in the area surrounding Yoxford. These include the river Yox, the Fromus and Minsmere New Cut, all statutory main rivers.

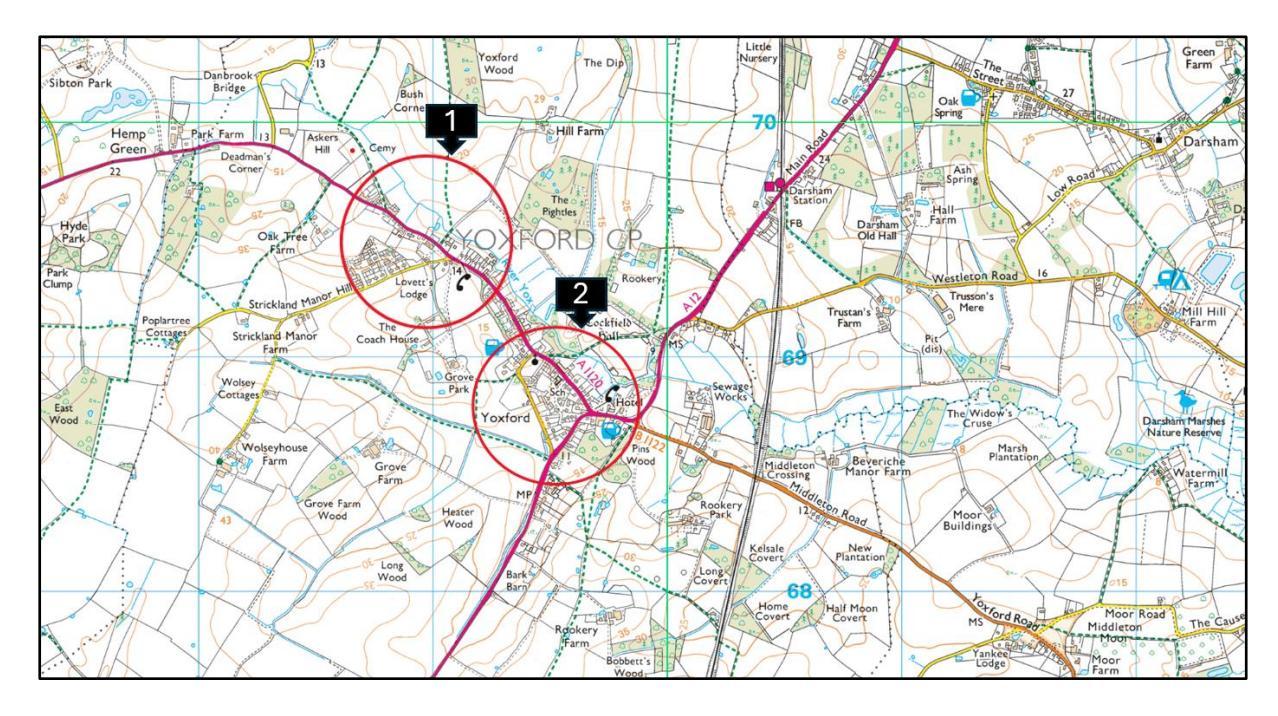
Figure 4. Yoxford investigation area map with locations

For the purposes of this investigation the various areas affected by flooding have been separated into two distinct locations (see Figure 4). The locations are as follows:

- 1. Little Street and The Lane
- 2. Old High Road, High Street and Brook Street

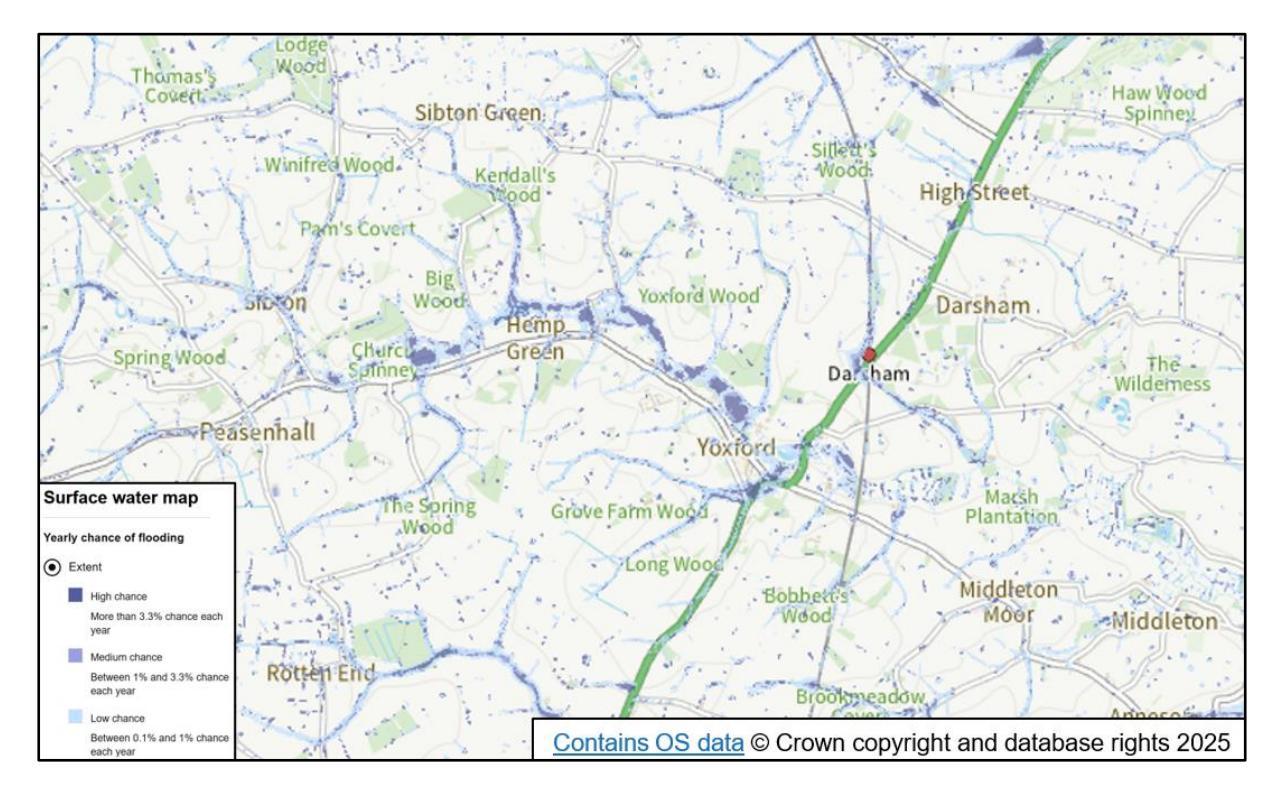
Figure 5. Surface water flood risk

The pluvial flood risk is prominent in the area around the junction of the A1120 and the A12 and on other sections of the A1120. Figure 5 highlights the pluvial (surface

water run-off from surrounding land and highways) flood risk in Yoxford. There are a number of isolated flow paths that come into the village from the west of the A1120 and A12, crossing the highway to reach the river Yox. Sections of Little Street, High Street, Old High Road and Brook Street are characterised as having a high chance of surface water flooding. These areas were significantly affected by flooding during Storm Babet.

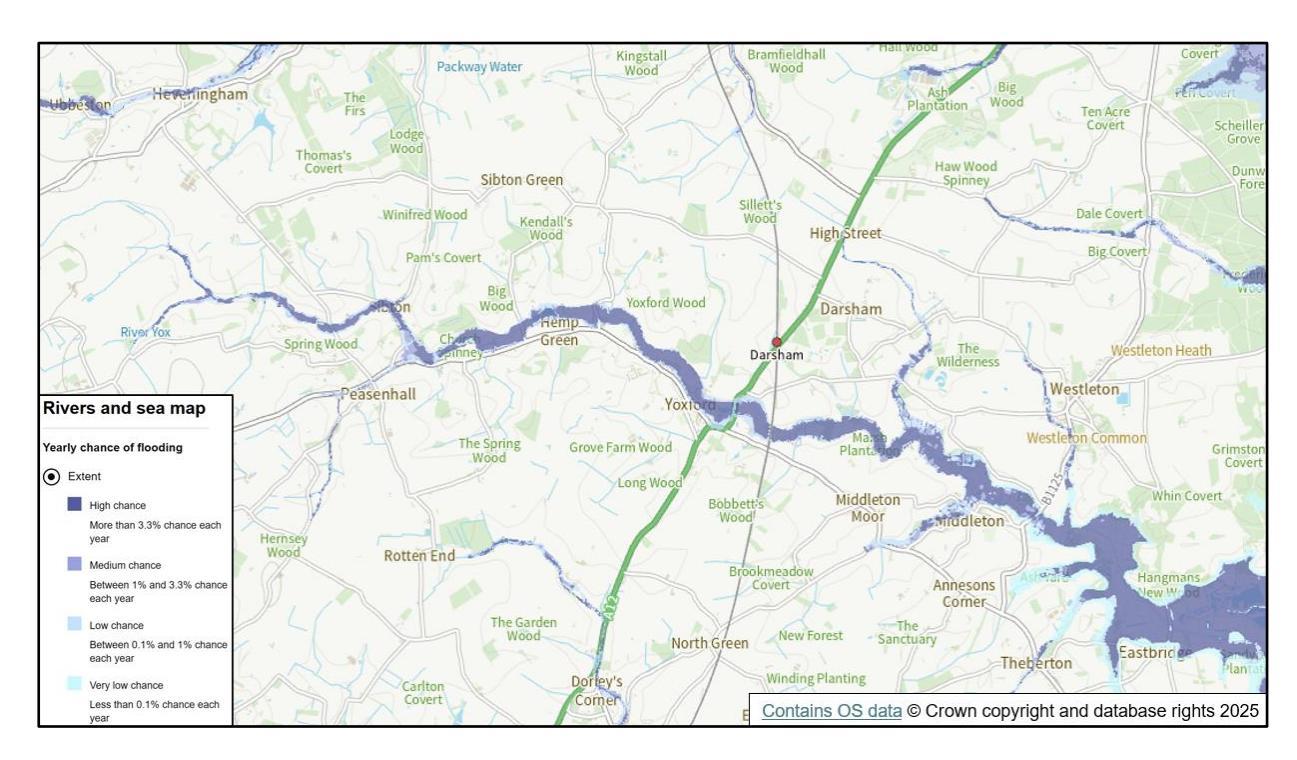
Figure 6. Flood risk from rivers and sea

Figure 6 shows the fluvial (from designated main river and ordinary watercourses) flood risk in Yoxford. Fluvial flood risk in the village is associated with the river Yox which flows through the village. In Yoxford, parts of The Lane, High Street and Brook Street are characterised as having a low chance of fluvial flooding. Some properties on High Street were affected by fluvial flooding during Storm Babet.

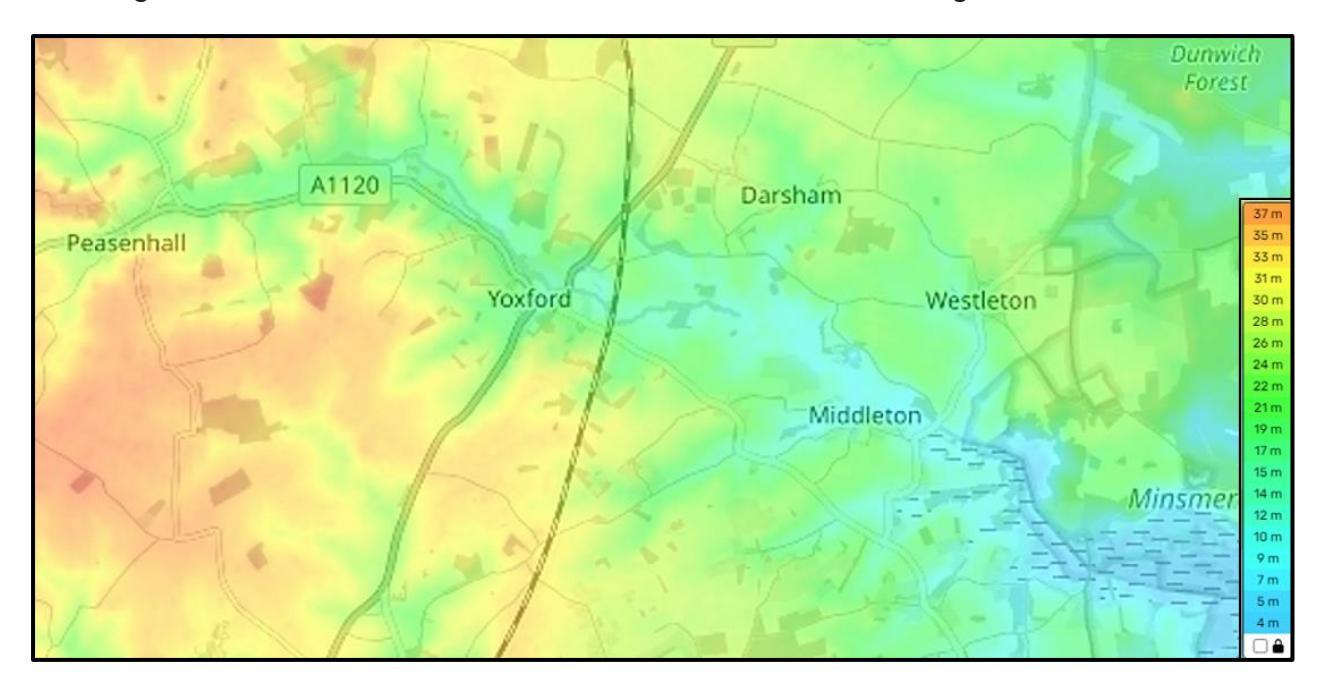
Figure 7. Yoxford and surrounding topography (TessaDEM as cited in topographic-map.com)

Figure 7 shows the topography and gradient changes surrounding Yoxford. The majority of the village is situated in the valley of the river Yox, lower than the surrounding land. The lowest point is along the section of the A12 close to the river crossing. This location was one of the worst affected areas during Storm Babet.

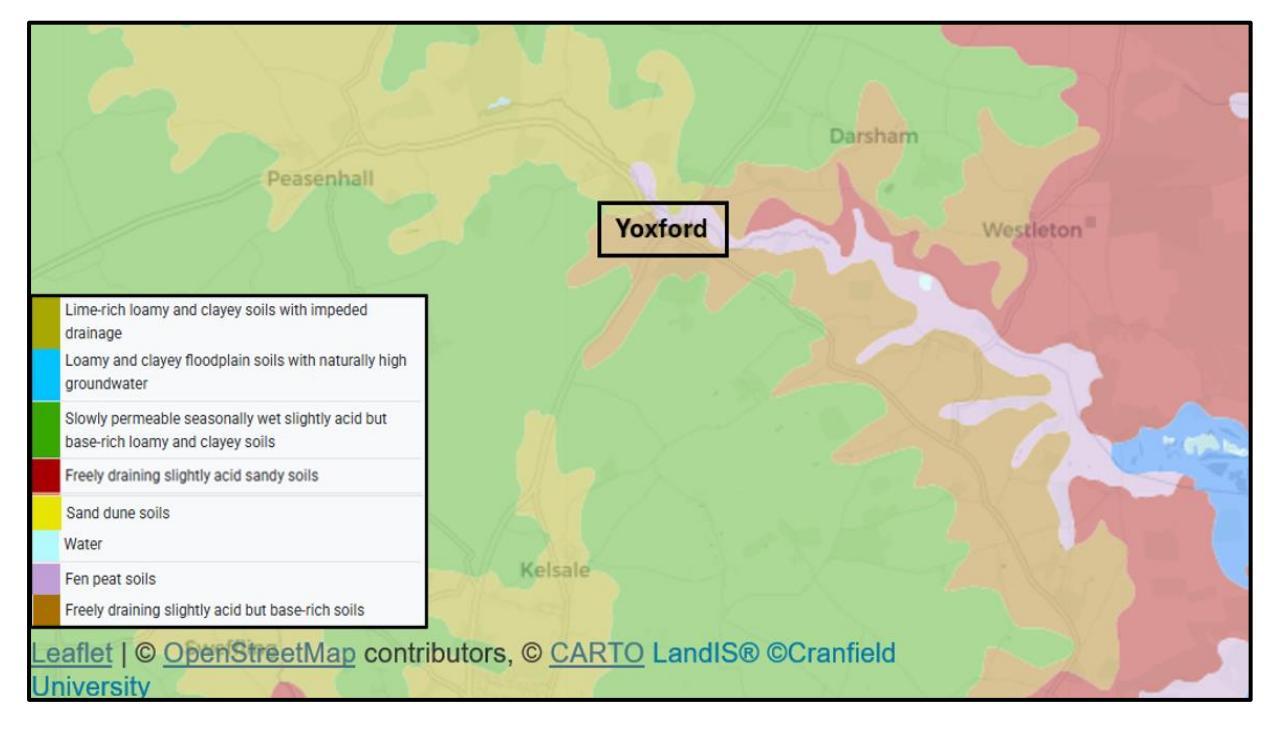
Figure 8. Soil map (LandIS Soilscapes)

The soils more generally surrounding Yoxford are loamy and clayey which is described as slowly permeable and seasonally wet. The centre of the village is situated on a mixture of lime-rich loamy and clayey soils with impeded drainage, freely draining soils and floodplain soils surrounding the river Yox which usually have naturally high groundwater and tend to be wetter.

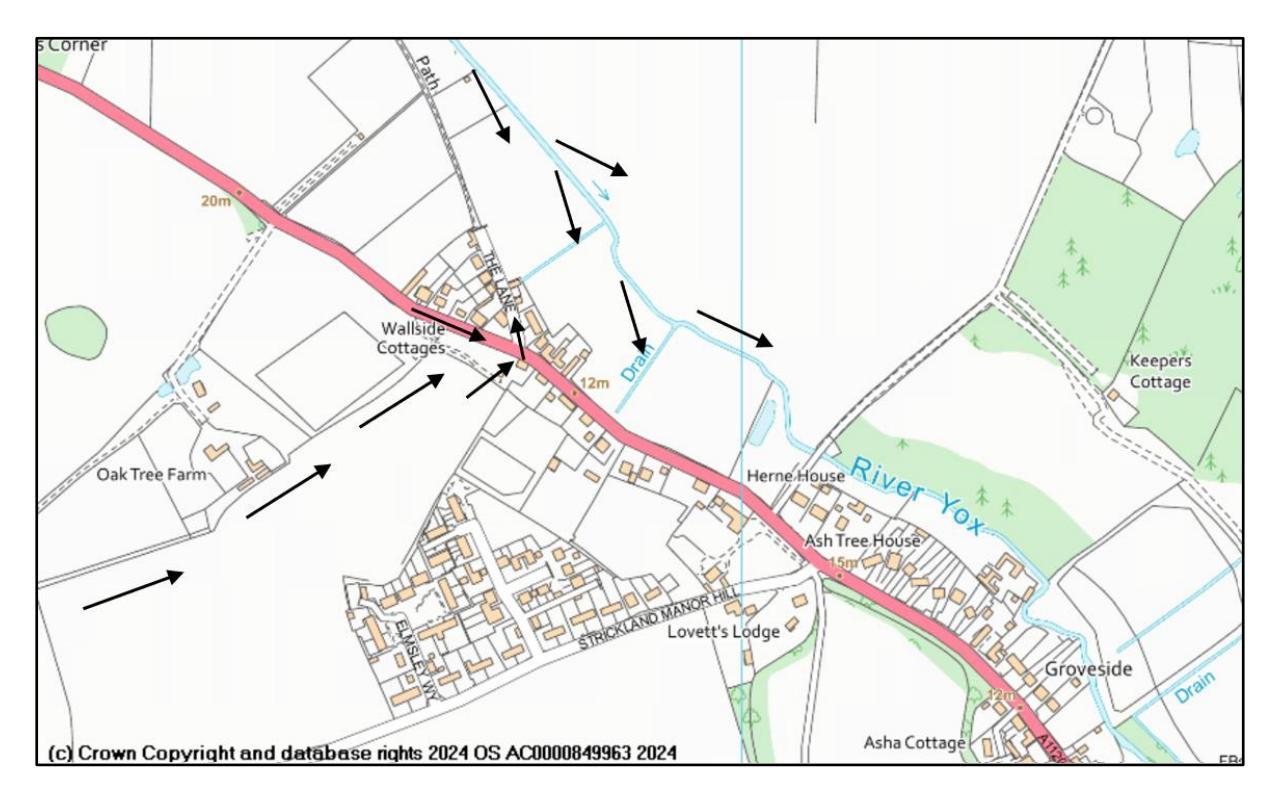
Figure 9. Approximate flood water flow routes affecting Little Street and The Lane

The primary cause of flooding on Little Street and The Lane was pluvial flooding. Following prolonged heavy rainfall on the morning of 20 October and the preceding two days, surface water flows running off the fields to the south of the A1120, crossed the A1120 and flowed onto The Lane (see Figure 9 & Image 2).

The surface water flows originated in the fields around and between Oak Tree Farm and Elmsley Way. Floodwater continued around and through gardens on Little Street impacting multiple properties from the side and rear. As the floodwater flowed in a torrent across the road, properties on The Lane were severely flooded from the front. Many of the properties are below road level with dropped kerbs in front, with the downward gradient from the road enabling the spread of the floodwater. Several residents commented on the sheer amount and velocity of water cascading off the upper fields, across the road and toward properties on The Lane. The highway was submerged (see Image 1).

- Residents to install Property Flood Resilience (PFR) via grant funded scheme.
- Investigate potential NFM projects to 'slow the flow' and attenuate water on overland flowpaths (leaky dams, restoration of watercourses, storage ponds etc.) in the fields south of the A1120 opposite The Lane.
- Suffolk Highways to ensure the completion of highway drainage asset cyclic maintenance on the A1120 and on The Lane.
- Riparian landowners to carry out appropriate watercourse maintenance to reduce flood risk as necessary as per their riparian responsibilities.

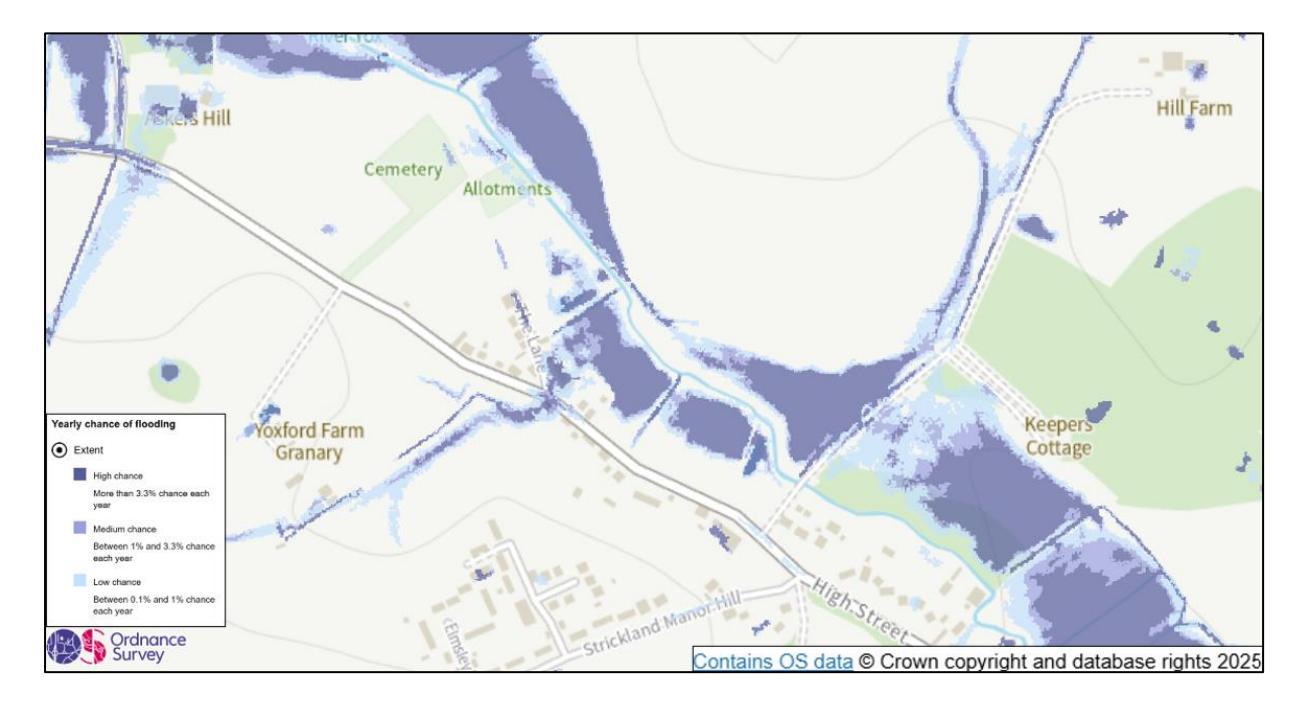
Figure 10. Surface water flood risk on Little Street and The Lane

The observed surface water flowpaths that directly affected properties on The Lane correlate closely with the surface water flood risk national mapping (see Figure 10). This is characterised as having a high chance of flooding each year.

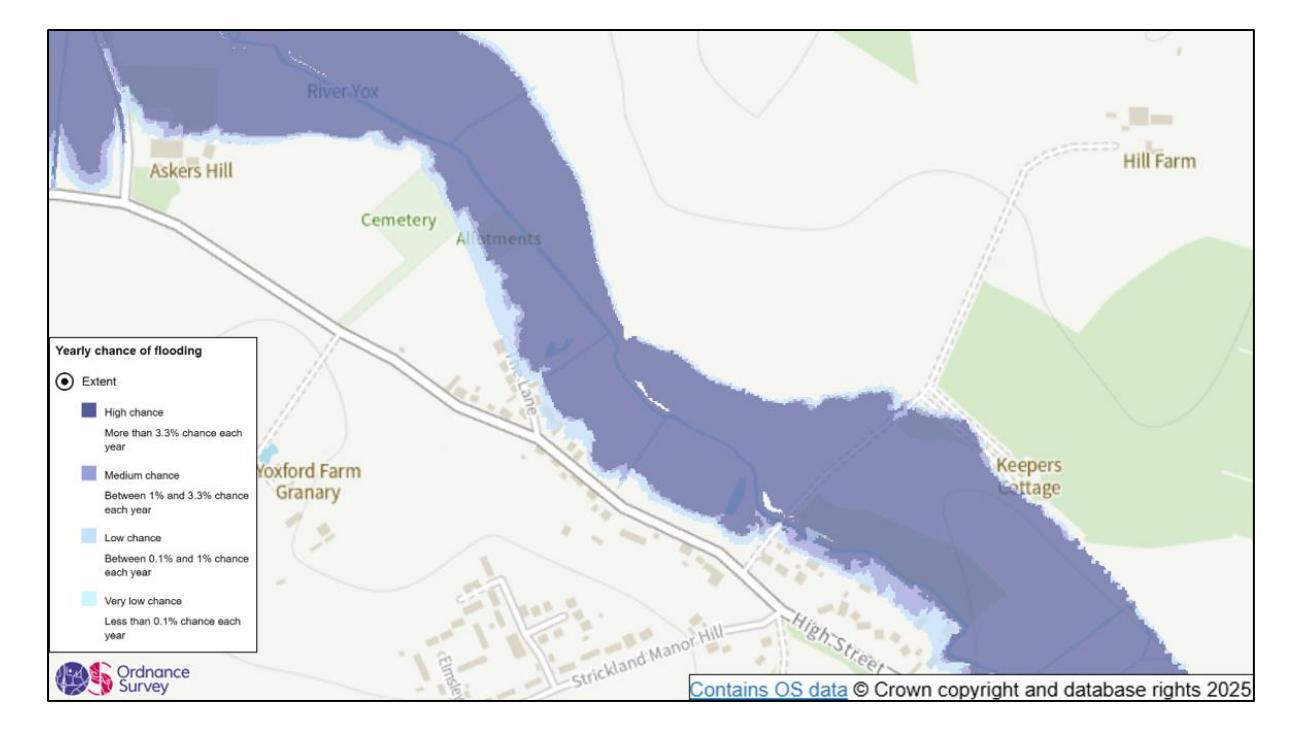
Figure 11. Flood risk from rivers and sea on Little Street and The Lane

It should be noted that properties in this location did not flood directly from the River Yox, but water levels were very high and rising into the fields behind the properties on The Lane. Fluvial flooding risk on The Lane is shown on Figure 11 below.

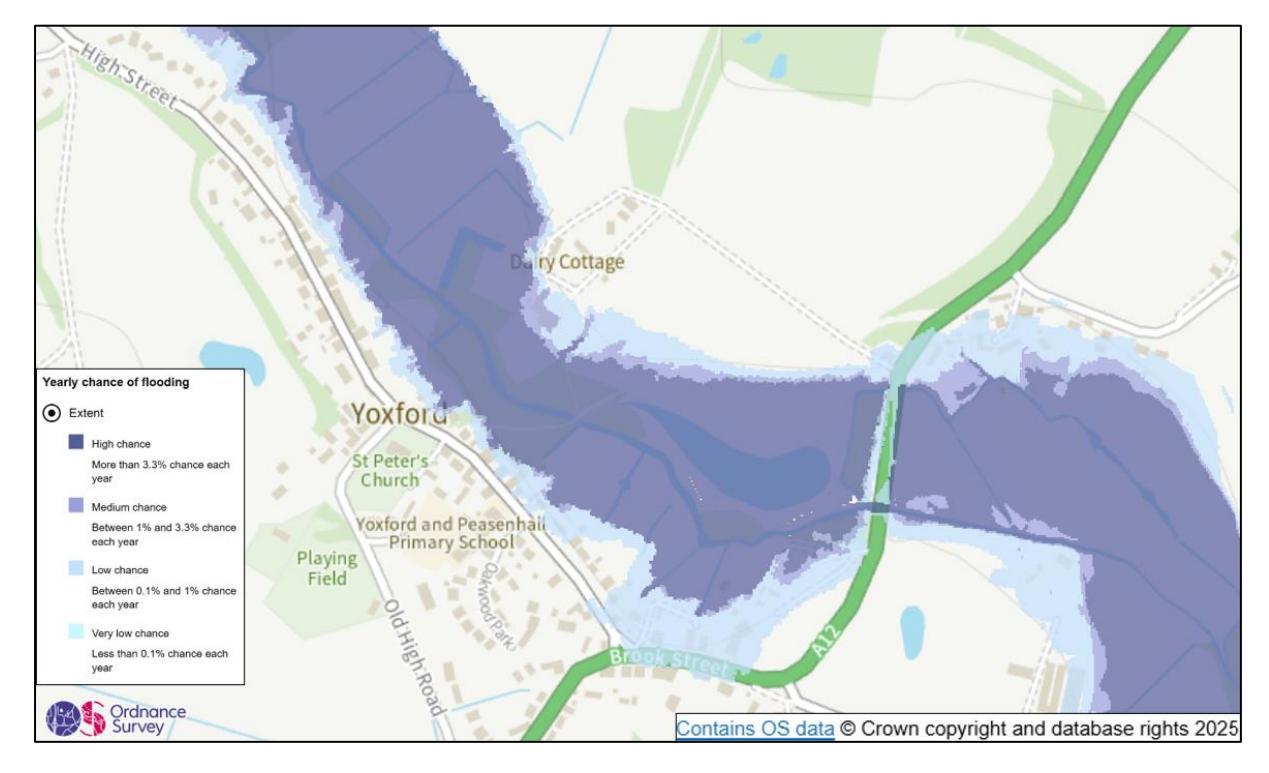
Figure 12. Flood risk from rivers and sea on High Street and Brook Street

As the river overtopped it's banks the floodwater travelled along the drainage channels into the lowest situated properties. Flood risk to properties along the High Street range from a low to high chance of flooding from the river each year (see Figure 12).

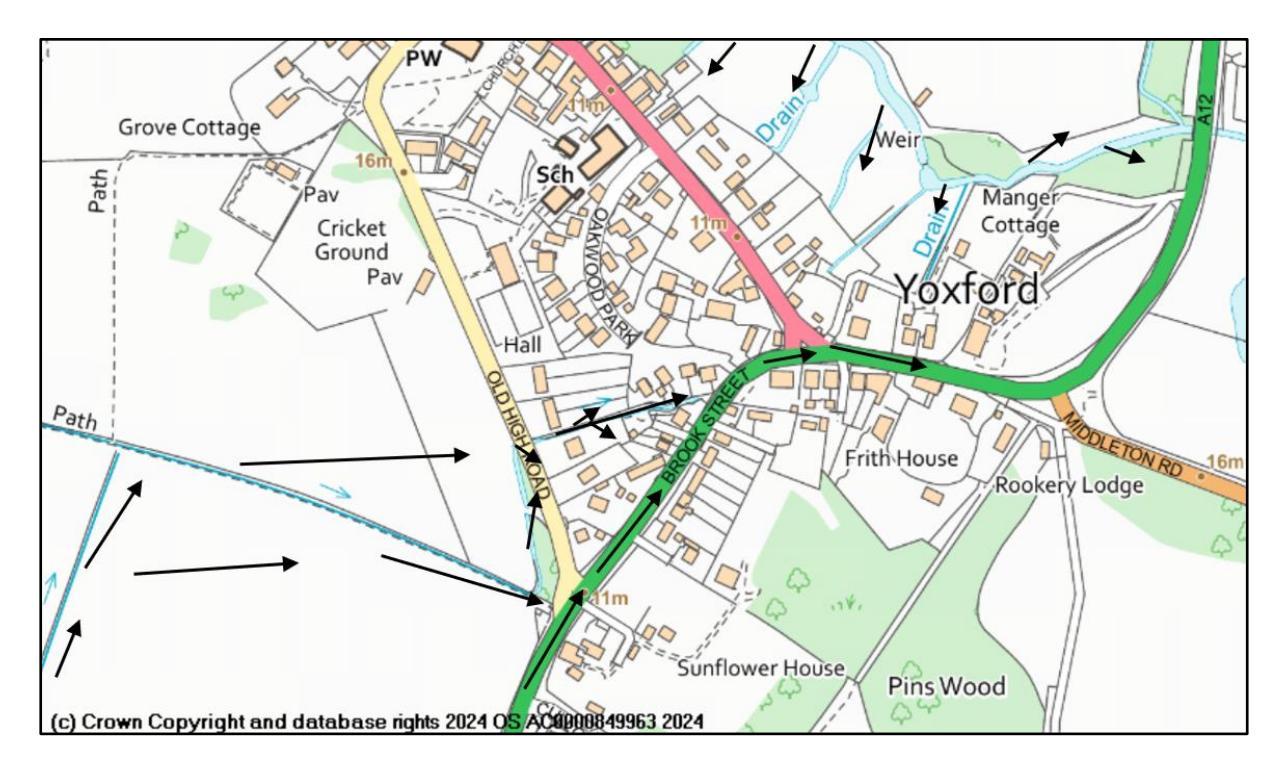
Figure 13. Approximate flood water flow routes affecting Old High Road, High Street and Brook Street

Properties were then flooded internally on Old High Road as the watercourse was overwhelmed and floodwater flowed through rear gardens (see Figure 13).

- Residents to install Property Flood Resilience (PFR) via grant funded scheme.
- Investigate potential NFM projects to 'slow the flow' and attenuate water on overland flowpaths in the fields (leaky dams, restoration of watercourses, storage ponds etc.) west of Old High Road and the A12 Main Road.
- Riparian landowners to carry out appropriate watercourse maintenance to reduce flood risk as necessary as per their riparian responsibilities.
- The Environment Agency to investigate if additional in channel maintenance of the river Yox through Yoxford is required.
- Suffolk Highways to ensure the completion of highway drainage asset cyclic maintenance on Old High Road and the A1120 / A12 junction.

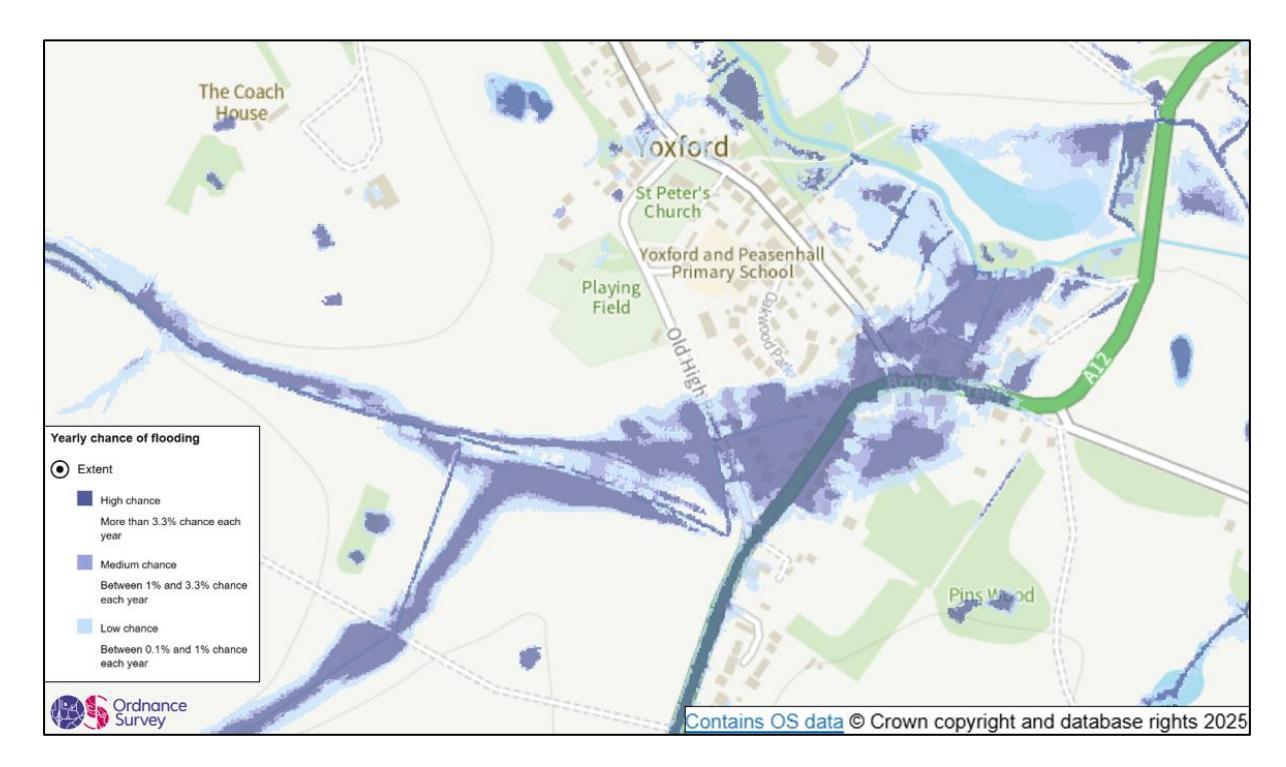
Figure 14. Surface water flood risk on Old High Road, High Street and Brook Street

A wide area centred around the A1120 / A12 junction is considered to be at a High yearly chance of surface water flooding (see Figure 14 & Image 5). The flood extents shown on the national flood mapping closely matches the observed floodwater limits seen during Storm Babet.

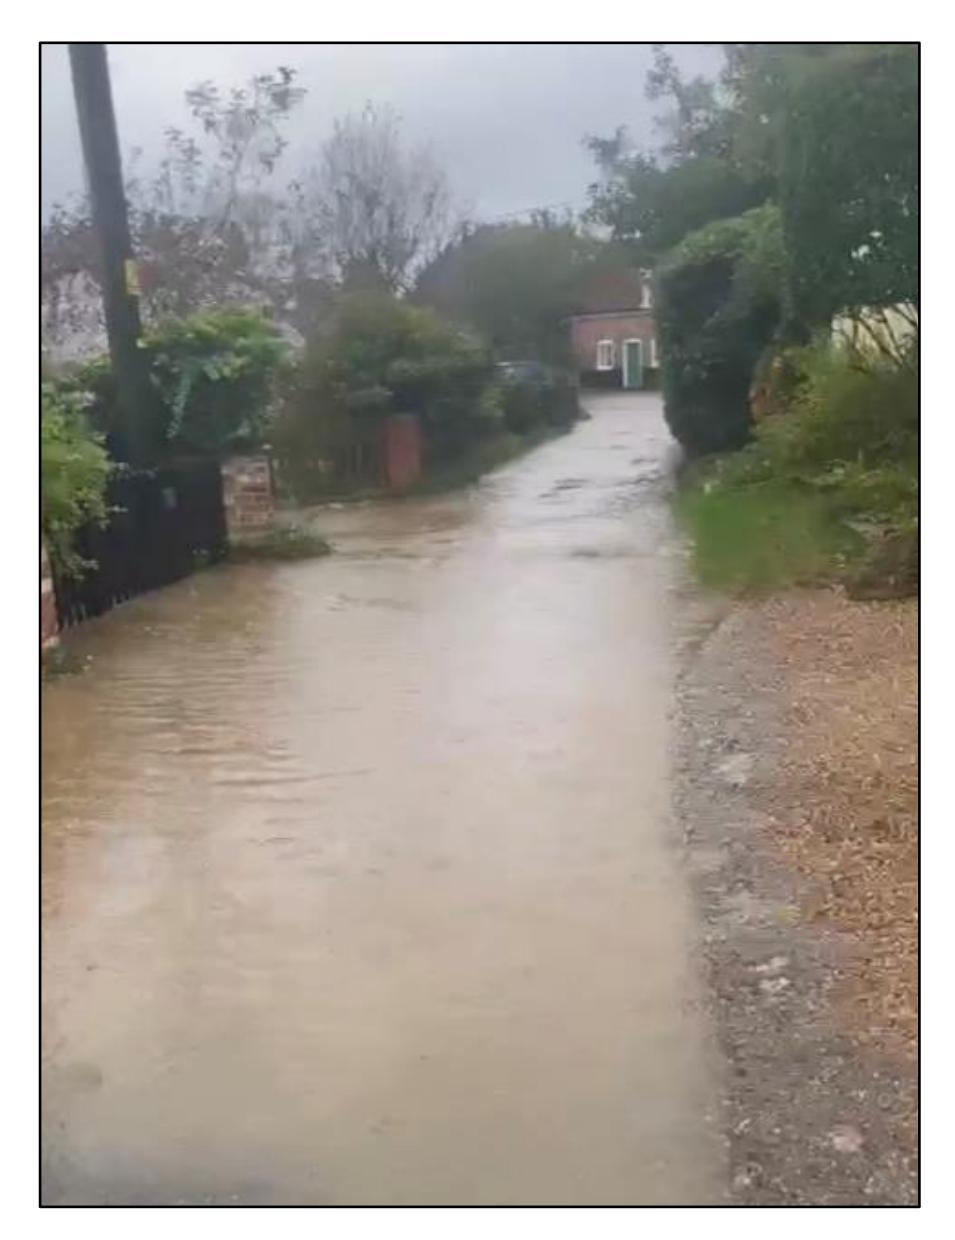
Image 1. Flooding on The Lane

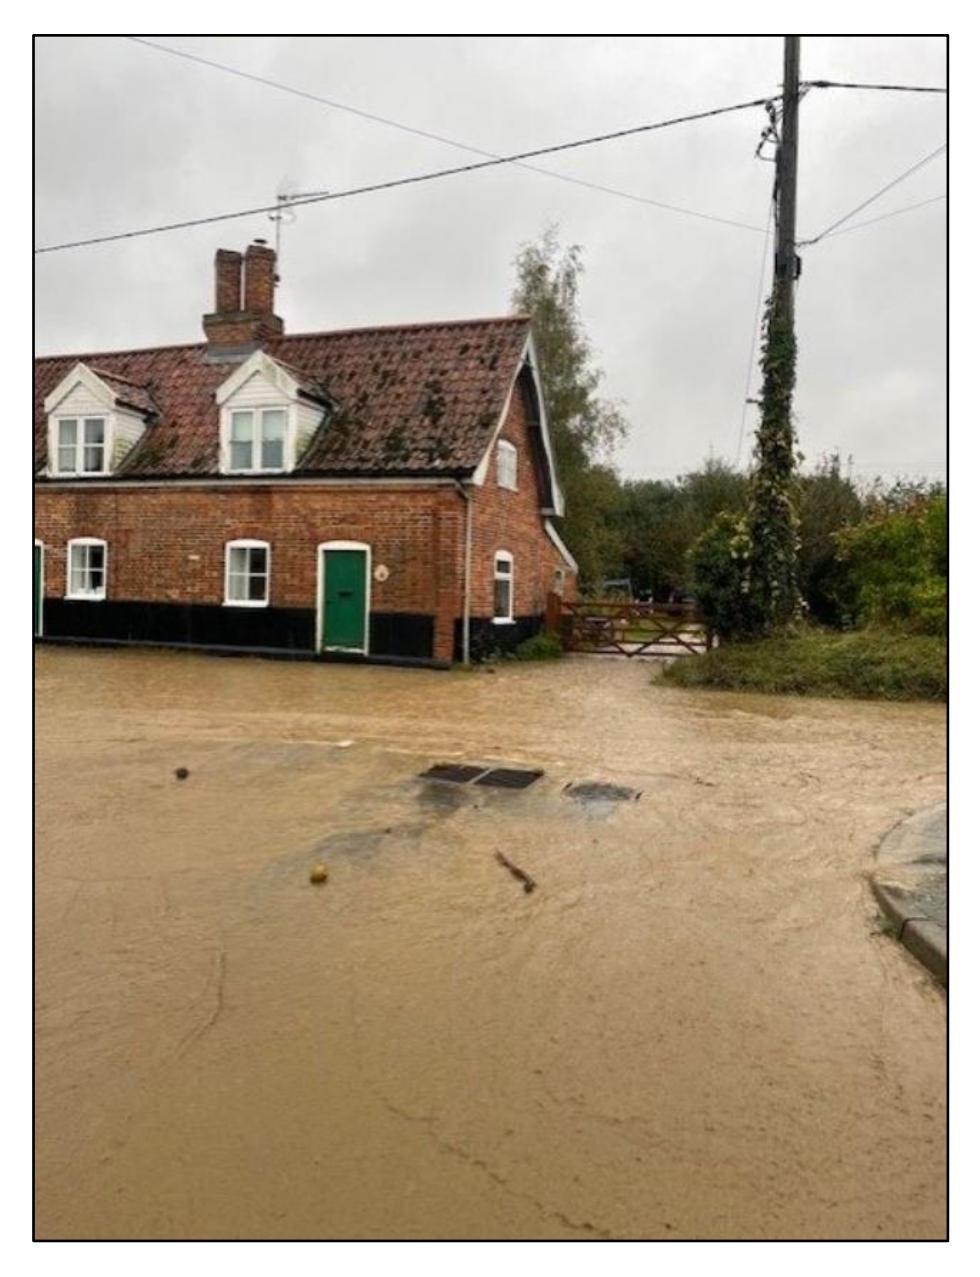
Image 2. View from The Lane onto the A1120

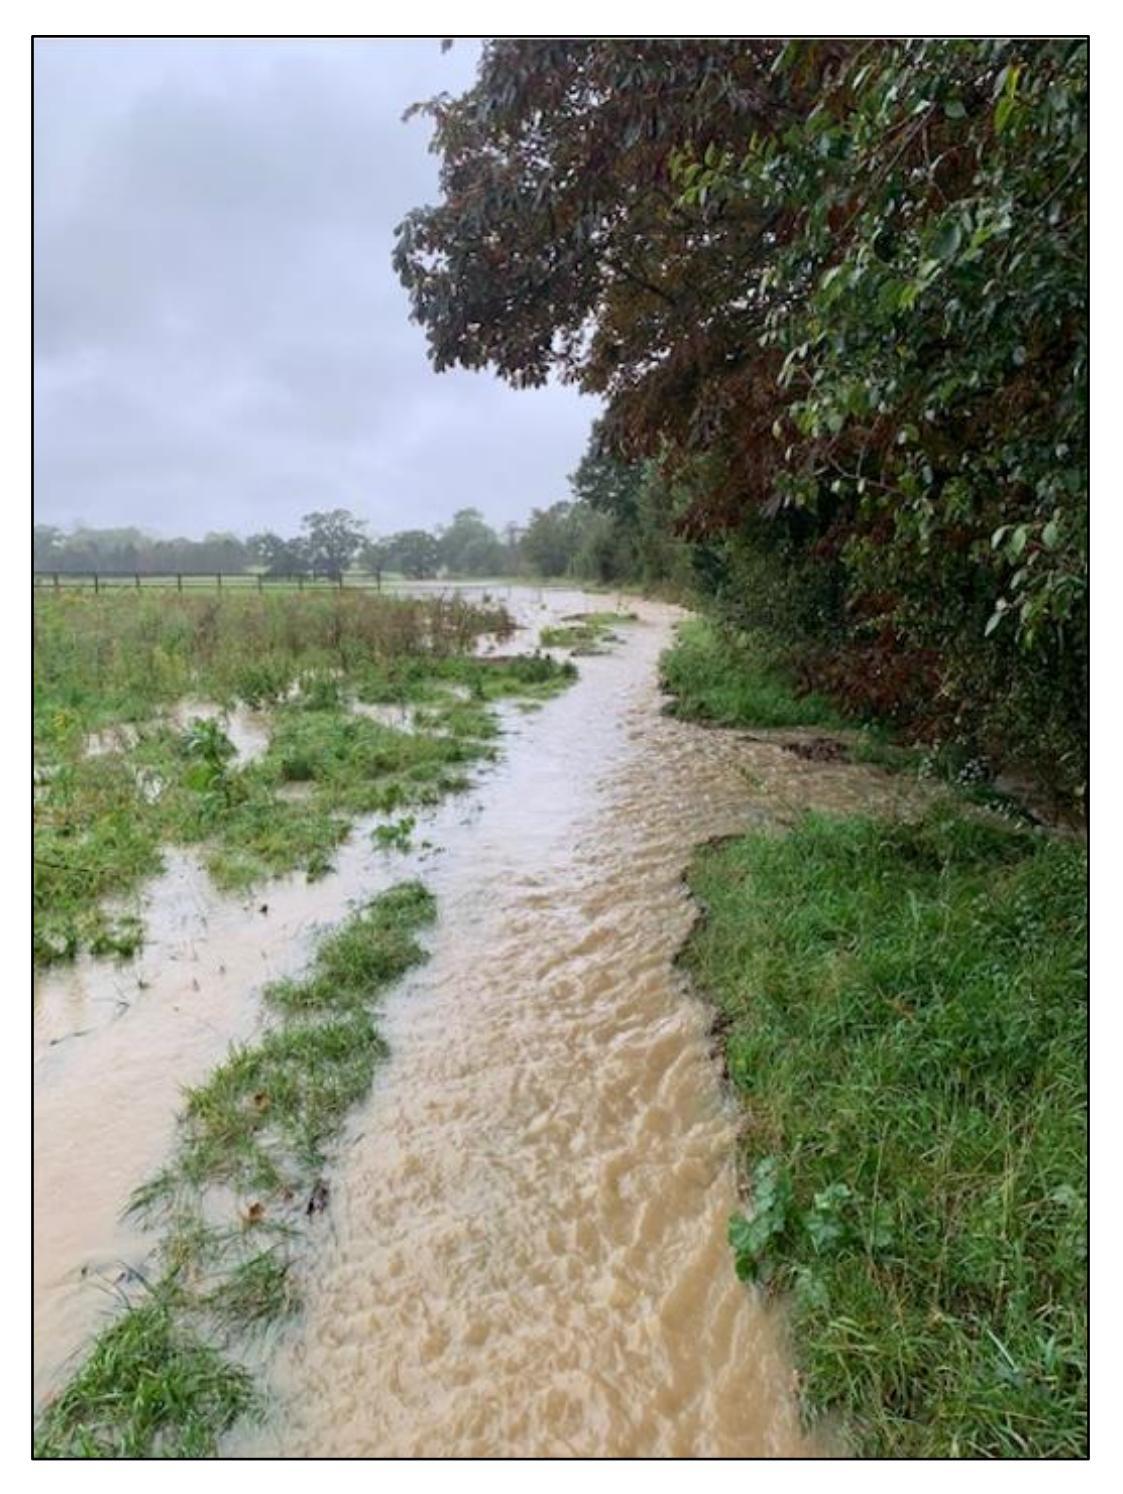
Surface water flowed from the five fields area (west of A12) along the footpath onto the A12 / Brook street from 11am onwards (Images 3 & 4). These surface water flows overwhelmed the capacity of the small roadside ditch. The amount of floodwater pooling along the highway rapidly exceeded the capacity of the existing drainage assets.

Image 3. Surface water flows on field west of the A12

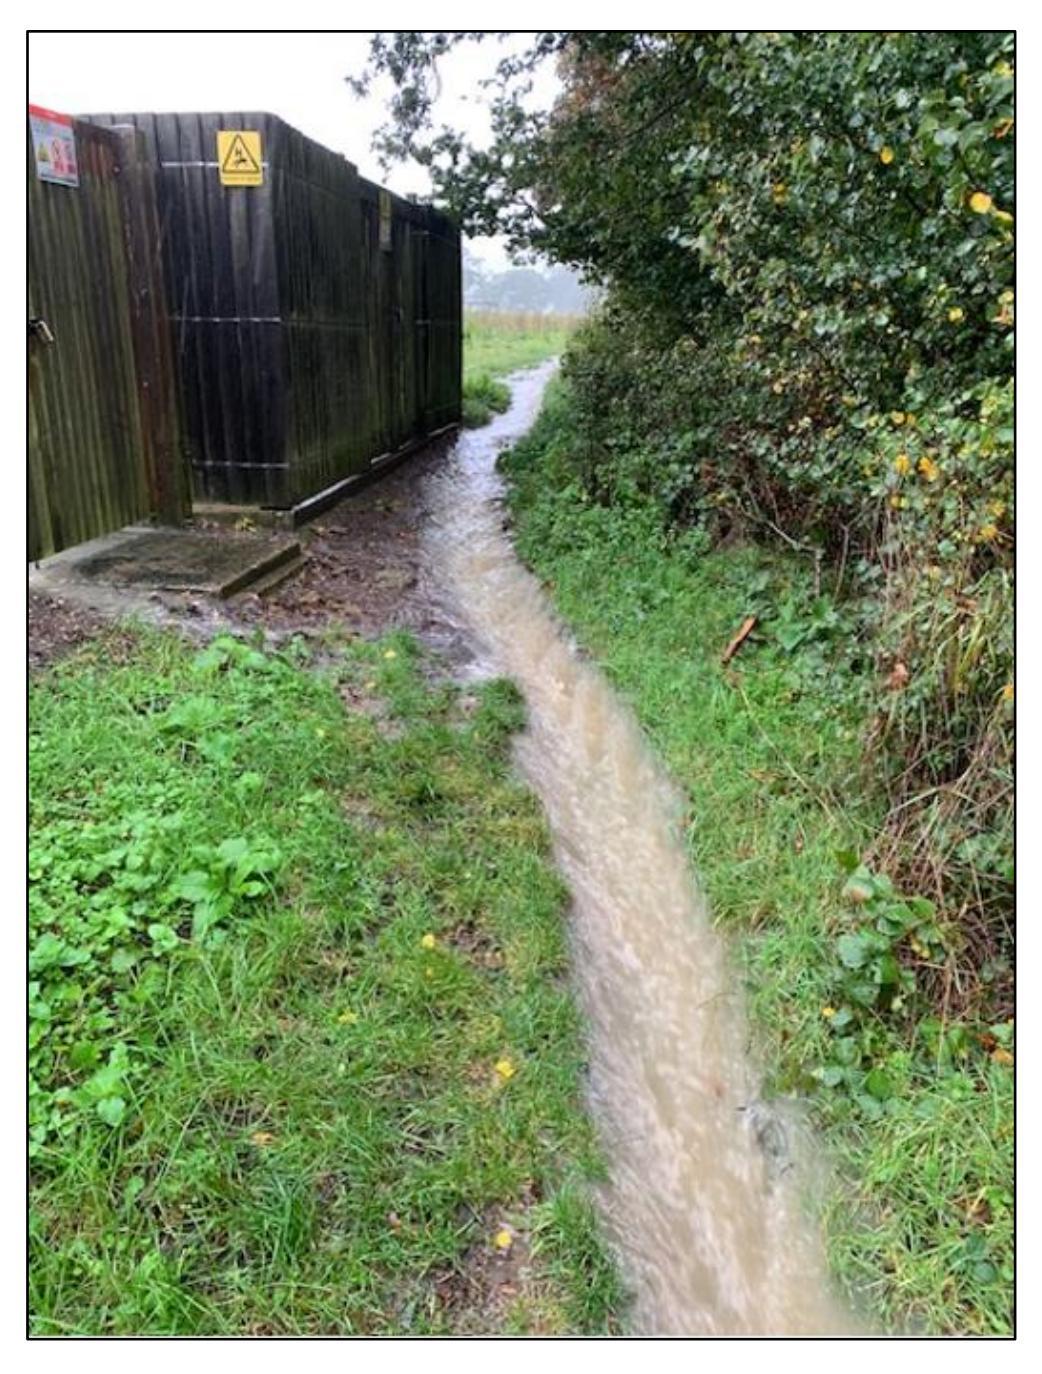
Image 4. Surface water flowing on footpath toward the A12

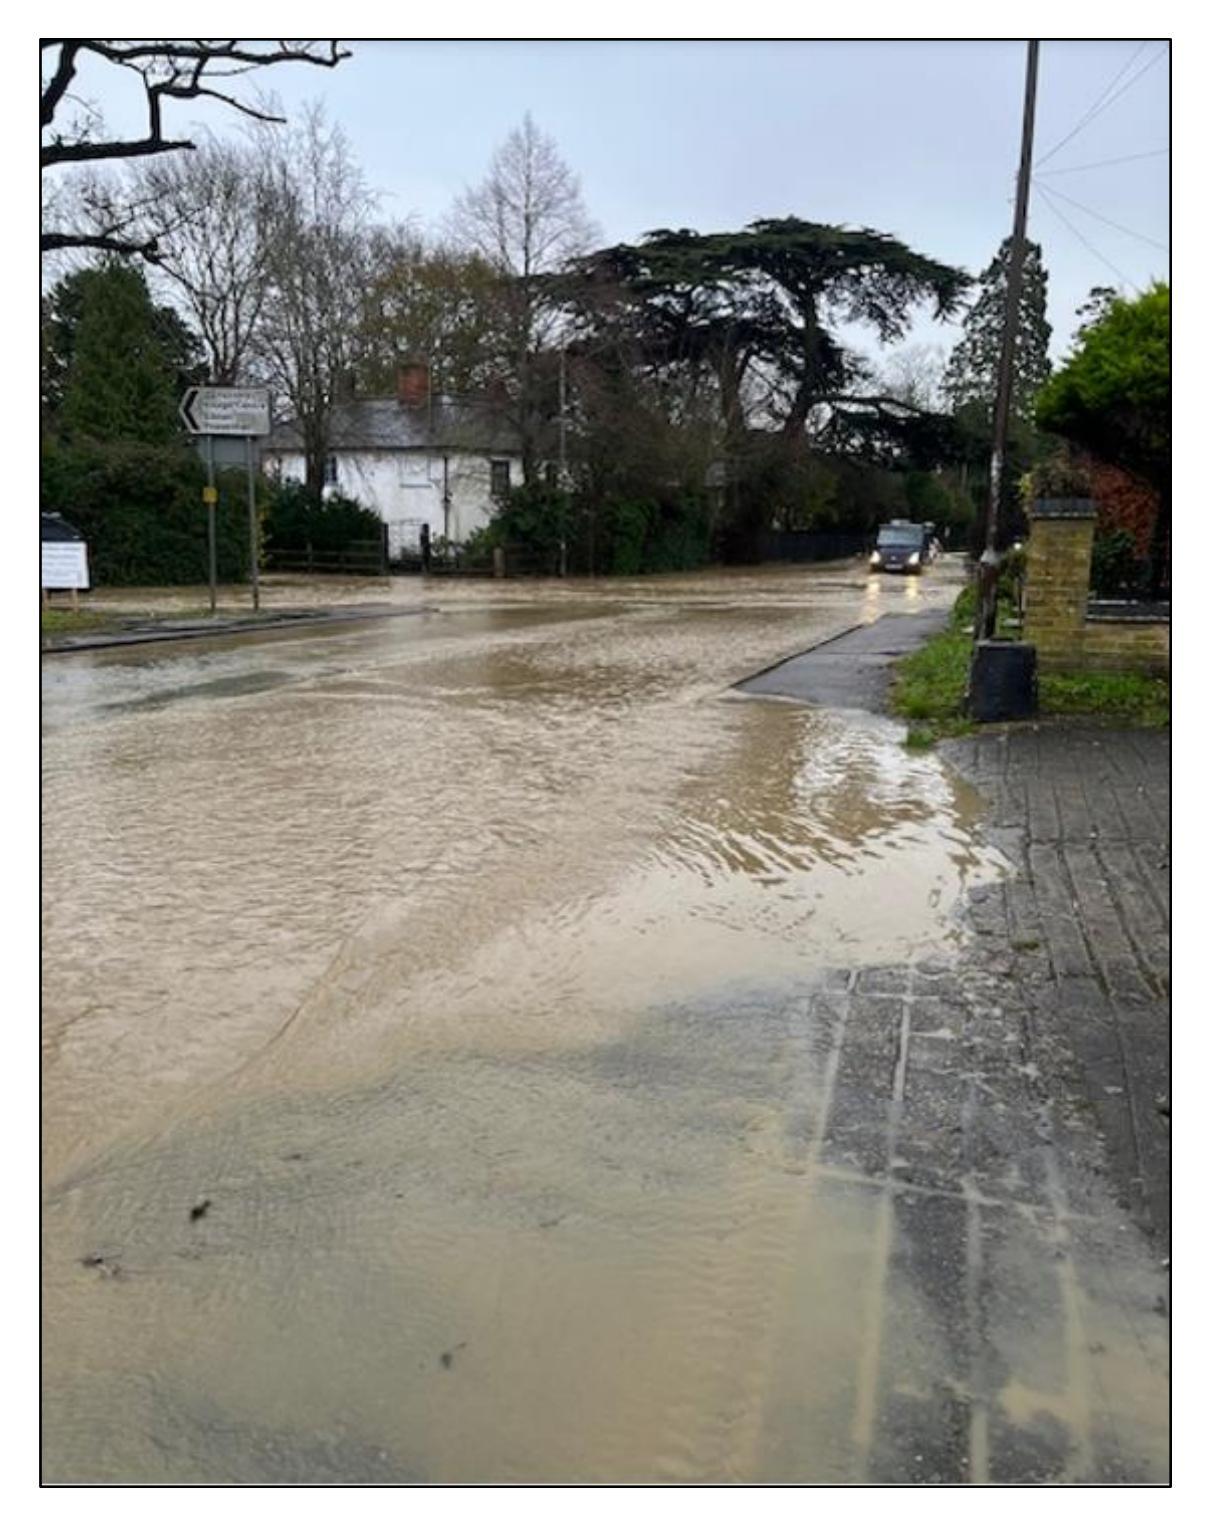
Image 5. Flooding on the A1120, A12 junction
