Section 19 Flood and Water Management Act 2010

Yoxford Flood Investigation -

Storm Babet 2023

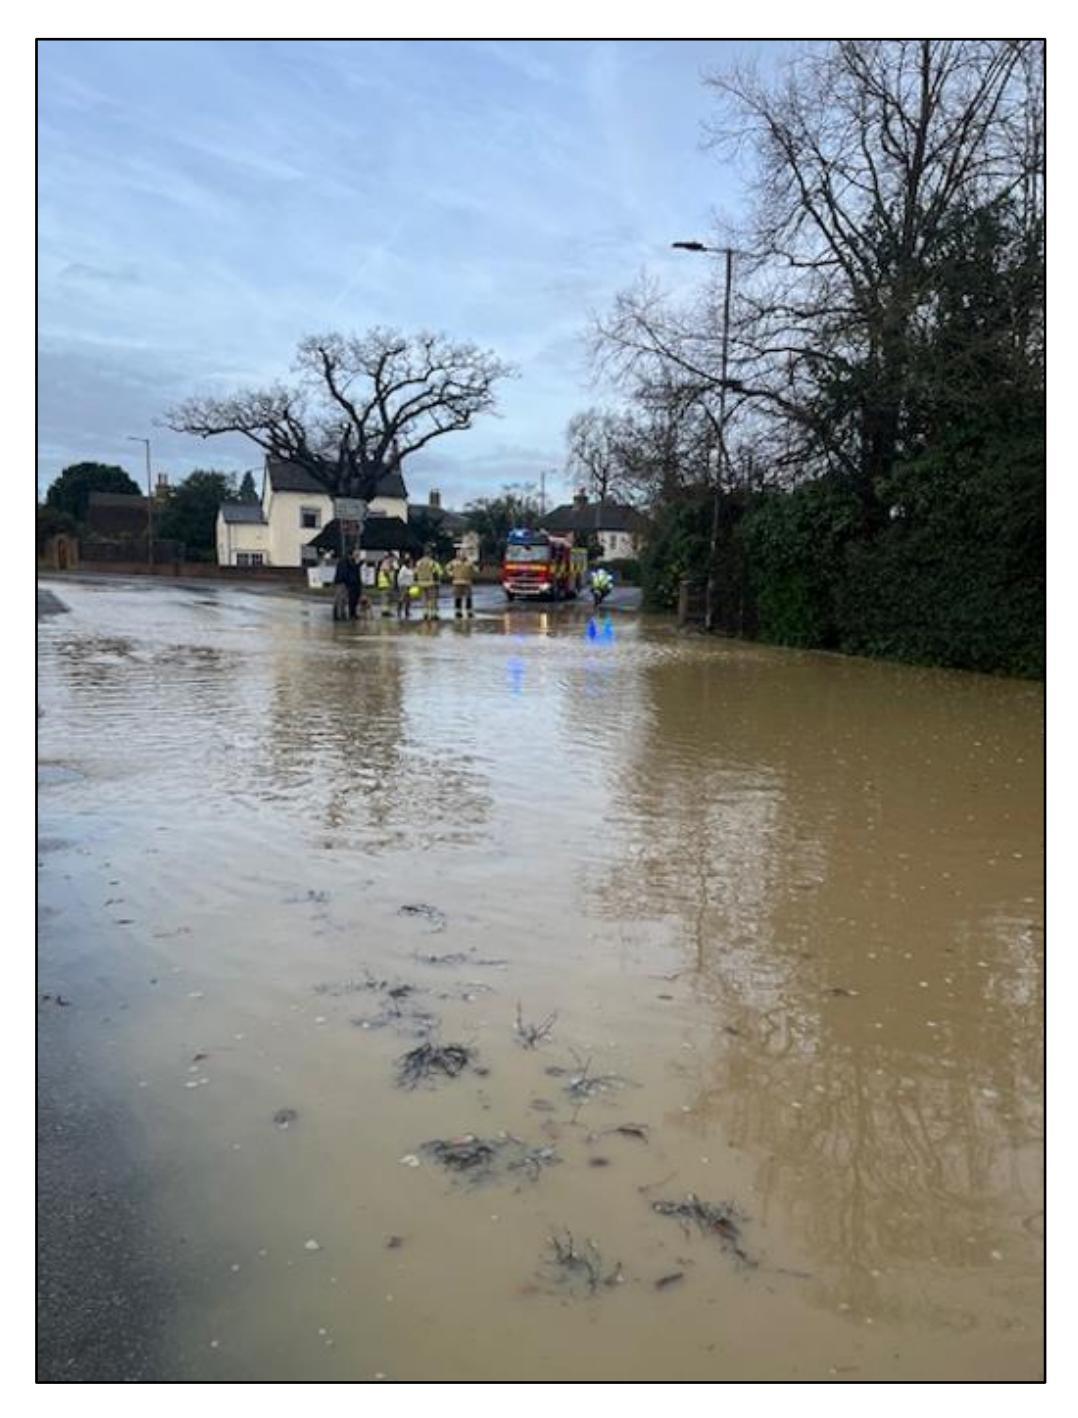
A property on Brook Street was flooded directly from the highway (see Image 6). As the extent of the floodwater grew throughout the morning into early afternoon, water entered through the air grates and the front door. Residents stated that at the time of Storm Babet, some of the highway drainage assets in and around the A1120 / A12 junction were blocked and or not fully operational.

Image 6. Flooding on Brook Street

- Residents to install Property Flood Resilience (PFR) via grant funded scheme.
- Investigate potential NFM projects to 'slow the flow' and attenuate water on overland flowpaths in the fields (leaky dams, restoration of watercourses, storage ponds etc.) west of Old High Road and the A12 Main Road.
- Riparian landowners to carry out appropriate watercourse maintenance to reduce flood risk as necessary as per their riparian responsibilities.
- The Environment Agency to investigate if additional in channel maintenance of the river Yox through Yoxford is required.
- Suffolk Highways to ensure the completion of highway drainage asset cyclic maintenance on Old High Road and the A1120 / A12 junction.
