Environmental Information Regulations – Response - 27434

Asset Location History Report Aurora

USRN:	1510787
Road Number:	A134
Address:	NEWTON ROAD
Town:	CHILTON
Maintaining Organisation:	SUFFOLK COUNTY COUNCIL
Street Type:	Designated Street Name
Highest Carriageway Reinstatement:	Carriageway type 2 (2.5 to 10 MSA)
Urban or Rural:	Urban
Road Hierarchy:	Main Distributor (3a)
Footway Hierarchy:	Local Access Footways (4)
Length:	965.74

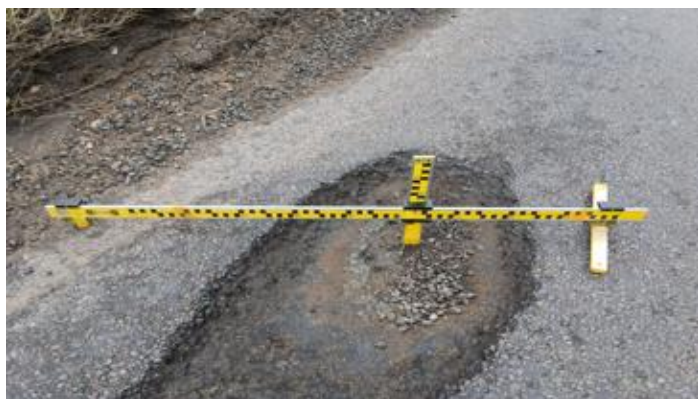
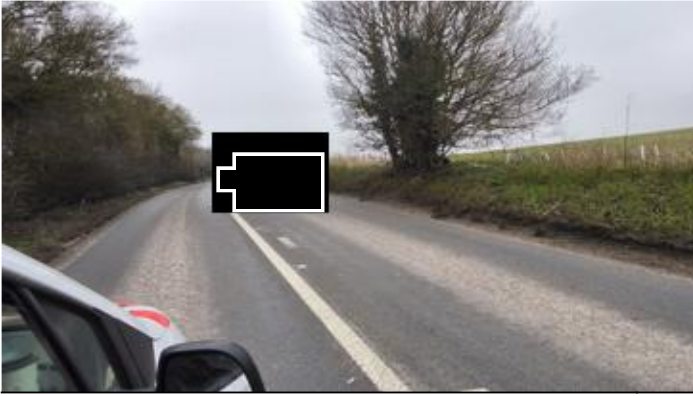
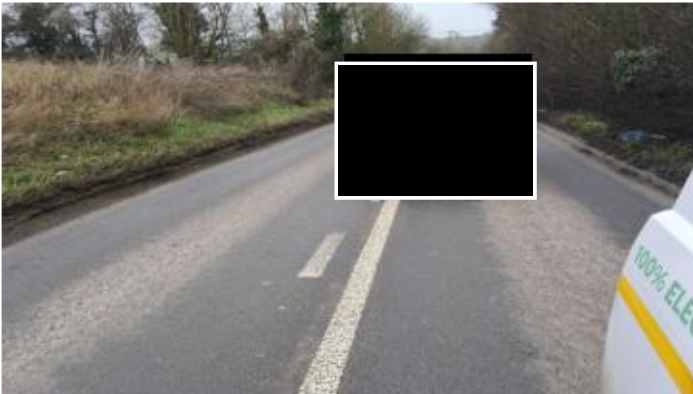
Ordered Date:	03/02/2026 11:38
Started Date:	13/02/2026 22:26
Completed Date:	13/02/2026 23:15
State:	Approved
Location:	.
Description:	10mm DBM Will Not Hold In This Road Type!
Order Number:	76
Priority:	P4 - 10 Working Days
Client Target Completion Due:	10 Day(s)
Contractor Target Completion Due:	10 Day(s)
Client Completion Due:	17/02/2026 11:36
Contractor Completion Due:	18/02/2026 16:30
Grid Ref.:	589308 241661
Likelihood:	Likely- 40-100mm
Defect length & width (specify mm or m):	0.6x1m
Defect depth / level difference (mm):	40mm
Action required:	Patch
Position in road/footway/verge:	Road
Speed limit (mph):	30
Road width (m):	6m
Footway width (m):	na
Available width for TM (m):	3m
Marked up on site?:	Yes
Volume of traffic/pedestrian movement:	Heavy

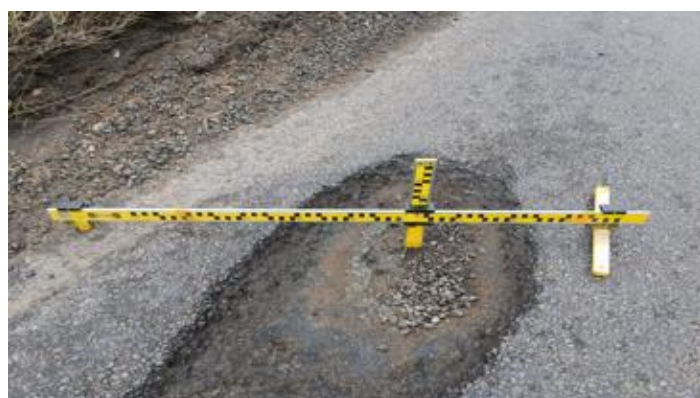
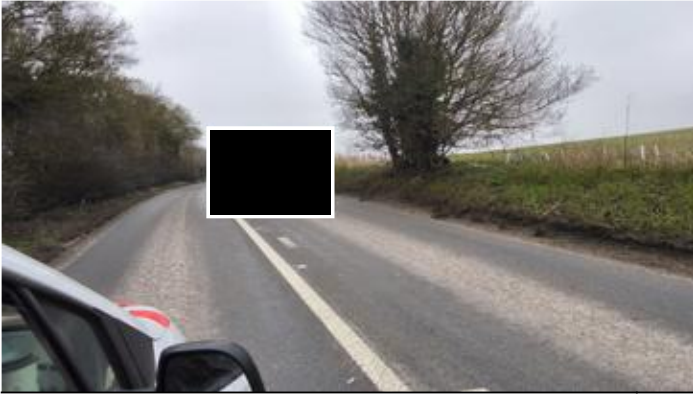
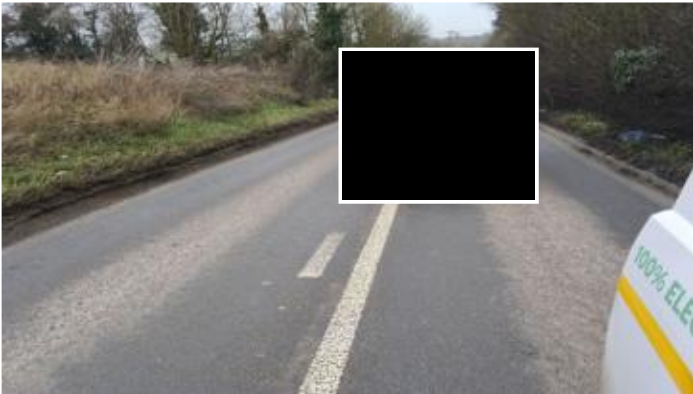
Action Number:	42020
Action Type:	Reactive Highways Maintenance
Asset Type:	Carriageway
Asset:	Newton Road,Chilton, Suffolk
Defect Type:	Matrix C - Carriageway Defects
Due Date:	17/02/2026 11:36
Ordered Date:	03/02/2026 11:38
Started Date:	13/02/2026 22:26
Completed Date:	13/02/2026 23:15
State:	Approved
Location:	.
Description:	10mm DBM Will Not Hold In This Road Type!
Order Number:	76
Priority:	P4 - 10 Working Days
Client Target Completion Due:	10 Day(s)

Contractor Target Completion Due:	10 Day(s)
Client Completion Due:	17/02/2026 11:36
Contractor Completion Due:	18/02/2026 16:30
Grid Ref.:	589308 241661
Likelihood:	Likely- 40-100mm
Defect length & width (specify mm or m):	0.6x1m
Defect depth / level difference (mm):	40mm
Action required:	Patch
Position in road/footway/verge:	Road
Speed limit (mph):	30
Road width (m):	6m
Footway width (m):	na
Available width for TM (m):	3m
Marked up on site?:	Yes
Volume of traffic/pedestrian movement:	Heavy
HAO Area:	HAO - All Areas Merged, HAO - Rougham 07
HAE Area:	HAE - Rougham
M Group Area:	MOA - West

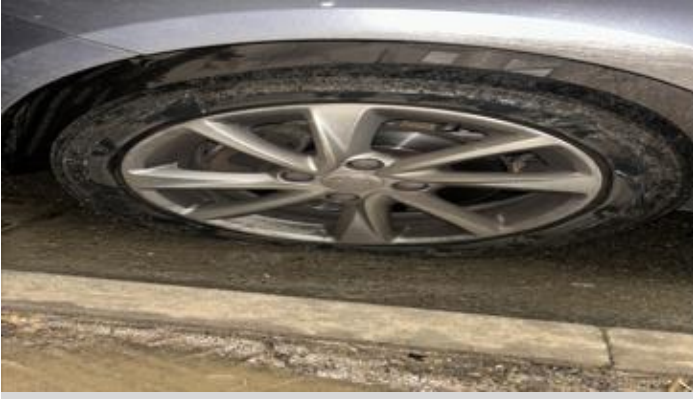
PWPFile-d2de4acd-c9cb-4ffa-a4be-7d5721277348.jpeg:

Case Type:	Pothole(s)
Case Number:	43165
Asset Type:	Carriageway
Originated Date:	05/02/2026 10:22
Service Level:	Standard
Location:	Approx 300 yards from the KFC/Esso roundabout heading into Sudbury
Description:	A very deep pothole approximately 300 yards from the KFC/Esso roundabout heading into Sudbury (from the main road of Colchester/Hadleigh etc) it has completely damaged my front passenger tyre resulting in a repair cost of over £100
State:	Cleared
Grid Ref.:	589076 241602

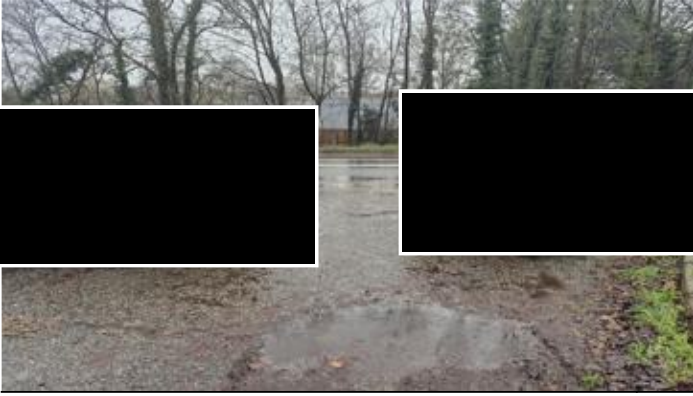
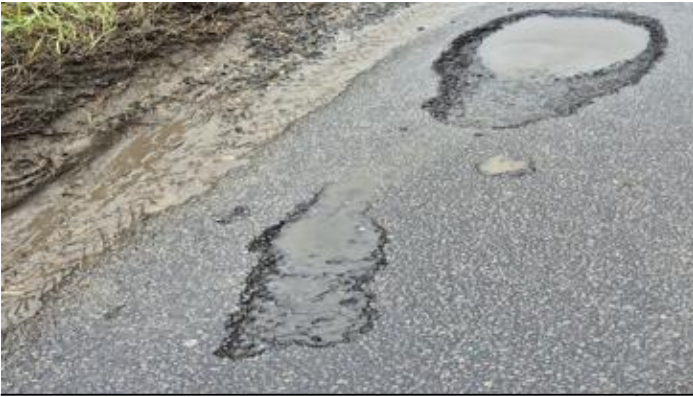
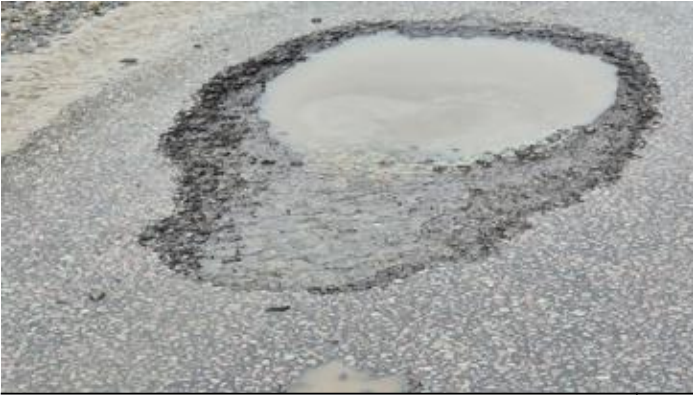
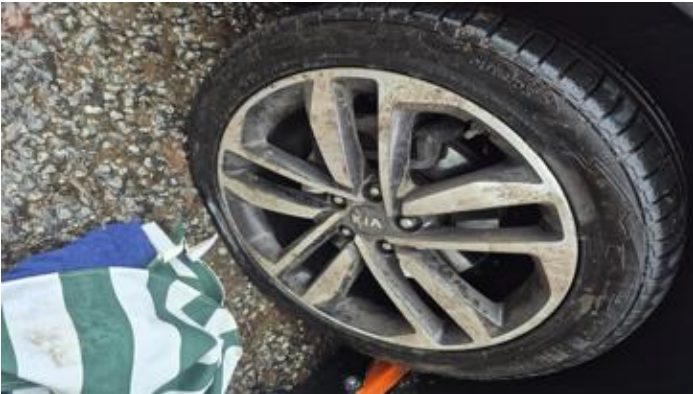
Case Type:	Pothole(s)
Case Number:	43836
Asset Type:	Carriageway
Originated Date:	06/02/2026 15:38
Service Level:	Standard
Location:	Top of hill as you go down to KFC
Description:	The pot hole is huge. On brow of hill. Cant see it until your ontop of it 3 of us in a row hit it. As when traffic coming you cant swerve and cant see it until youve hit it. Dangerous Cost me £140 on new tyre!!!!!!
State:	Cleared
Grid Ref.:	589456 241710

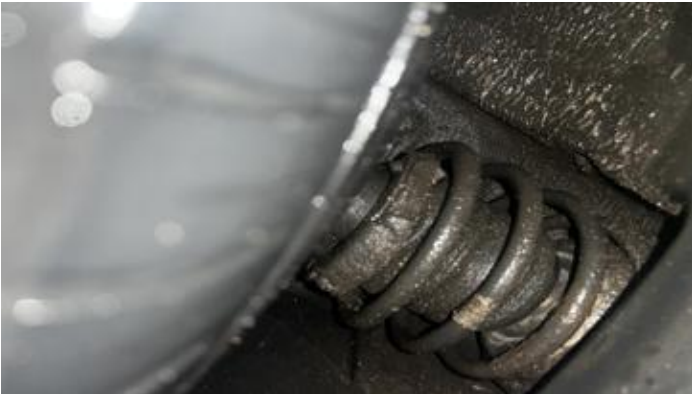
PWPFile-91daf033-441f-4c7d-a485-d2b72e7f9ac8.jpeg:

Case Type:	Pothole(s)
Case Number:	43908
Asset Type:	Carriageway
Originated Date:	06/02/2026 18:02
Service Level:	Standard
Location:	Left hand side of lane going downhill towards Sudbury.
Description:	Pothole. As you do down the hill towards Sudbury, in line with left hand side of vehicle, unable to be seen in dark or raining conditions. Has caused coil spring to snap and break at bottom of spring and no longer attached to the strut/ shock. causing damage to my car and unable to be driven a safe distances. Unable to get photo due to road being narrow and no safe access for pedestrians
State:	Cleared
Grid Ref.:	589334 241667

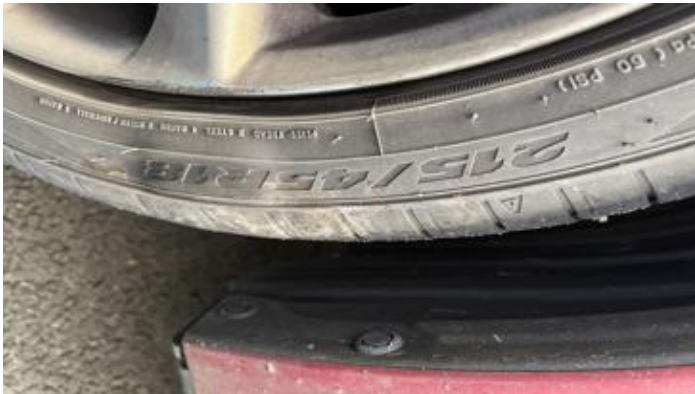
PWPFile-602170ce-e026-41d5-93f8-024837eb0301.jpeg:

Description: Large pothole, couple of hundred meters from the roundabout caused tyre damage to front left tyre on 12/02/2026. Have now booked a £157 tyre change to replace tyre that was new in September. Hard to avoid in the dark with traffic coming the other way. Only see it last minute and forced to go over it.
