**Lead Local Flood Authority**  
**Section 19 (Flood and Water Management Act**  
**2010)**  
**Flood Investigation Report**  
(Reformatted Version)

East Street and Elizabeth Courth  
Sudbury

FW2014-0378 to 0382

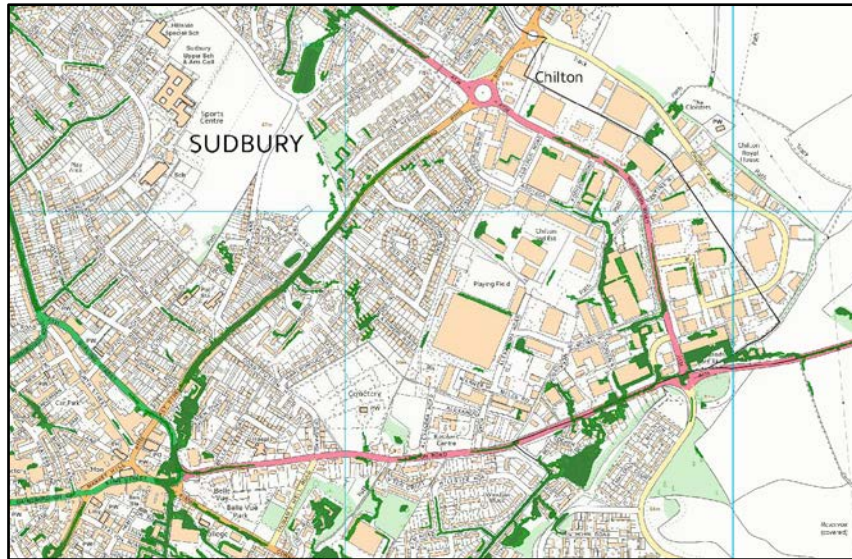
**2.13 Additional Information:** The area of East Street is listed on the pluvial flood maps as being at risk during a 1:30 and 1:100 year rainfall events.
