**Lead Local Flood Authority**  
**Section 19 (Flood and Water Management Act**  
**2010)**  
**Flood Investigation Report**  
(Reformatted Version)

Bury Road

Lawshall

FW2014-0460/0462

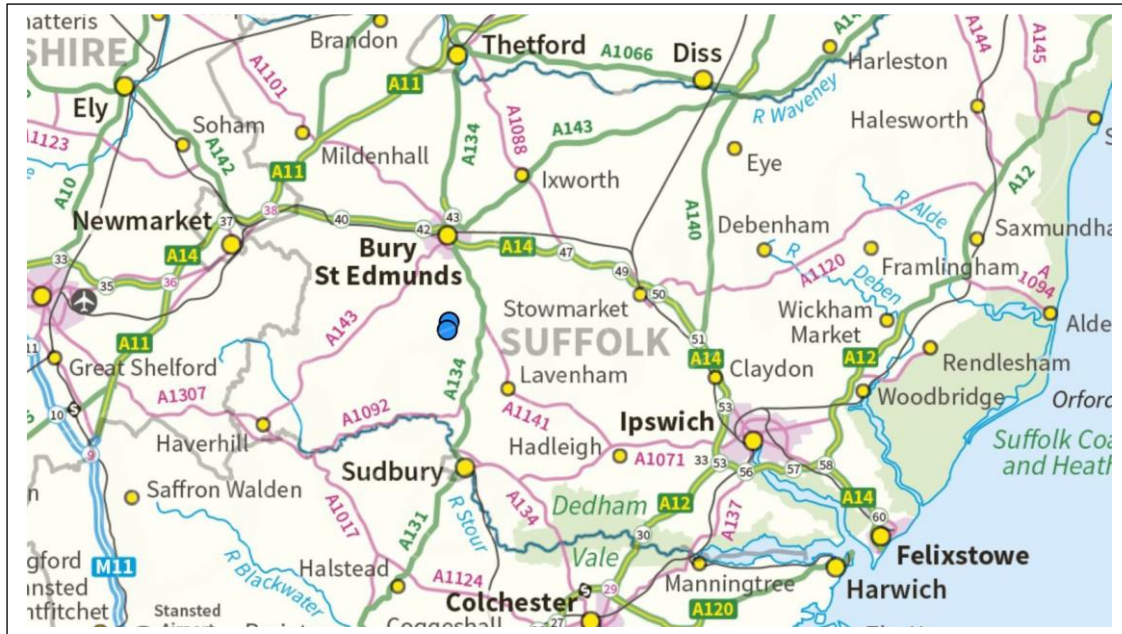
**2.6 OS Grid Reference:** TL 85545508 and TL 85715587

**2.7 Extent of flooding:** Deep surface water (>0.3m) in two specific locations: -

- The junction of Bury Road/Lawshall Row up to Windsor Close where severely 5 properties were affected – referred to as *Bury Rd South*
- Northern section of Bury Road for 20m where 2 properties were severely affected – referred to as *Bury Rd North*

Both these areas are the lowest points in their respective sub-catchments. Bury Rd South also suffered from sewer flooding.
